Restoration of the Old Bridge

# MOSTAŘ 2004 PROJECT

# NEZIRAGINA MOSQUE

## THE CEJVANBEGOV HAMAM

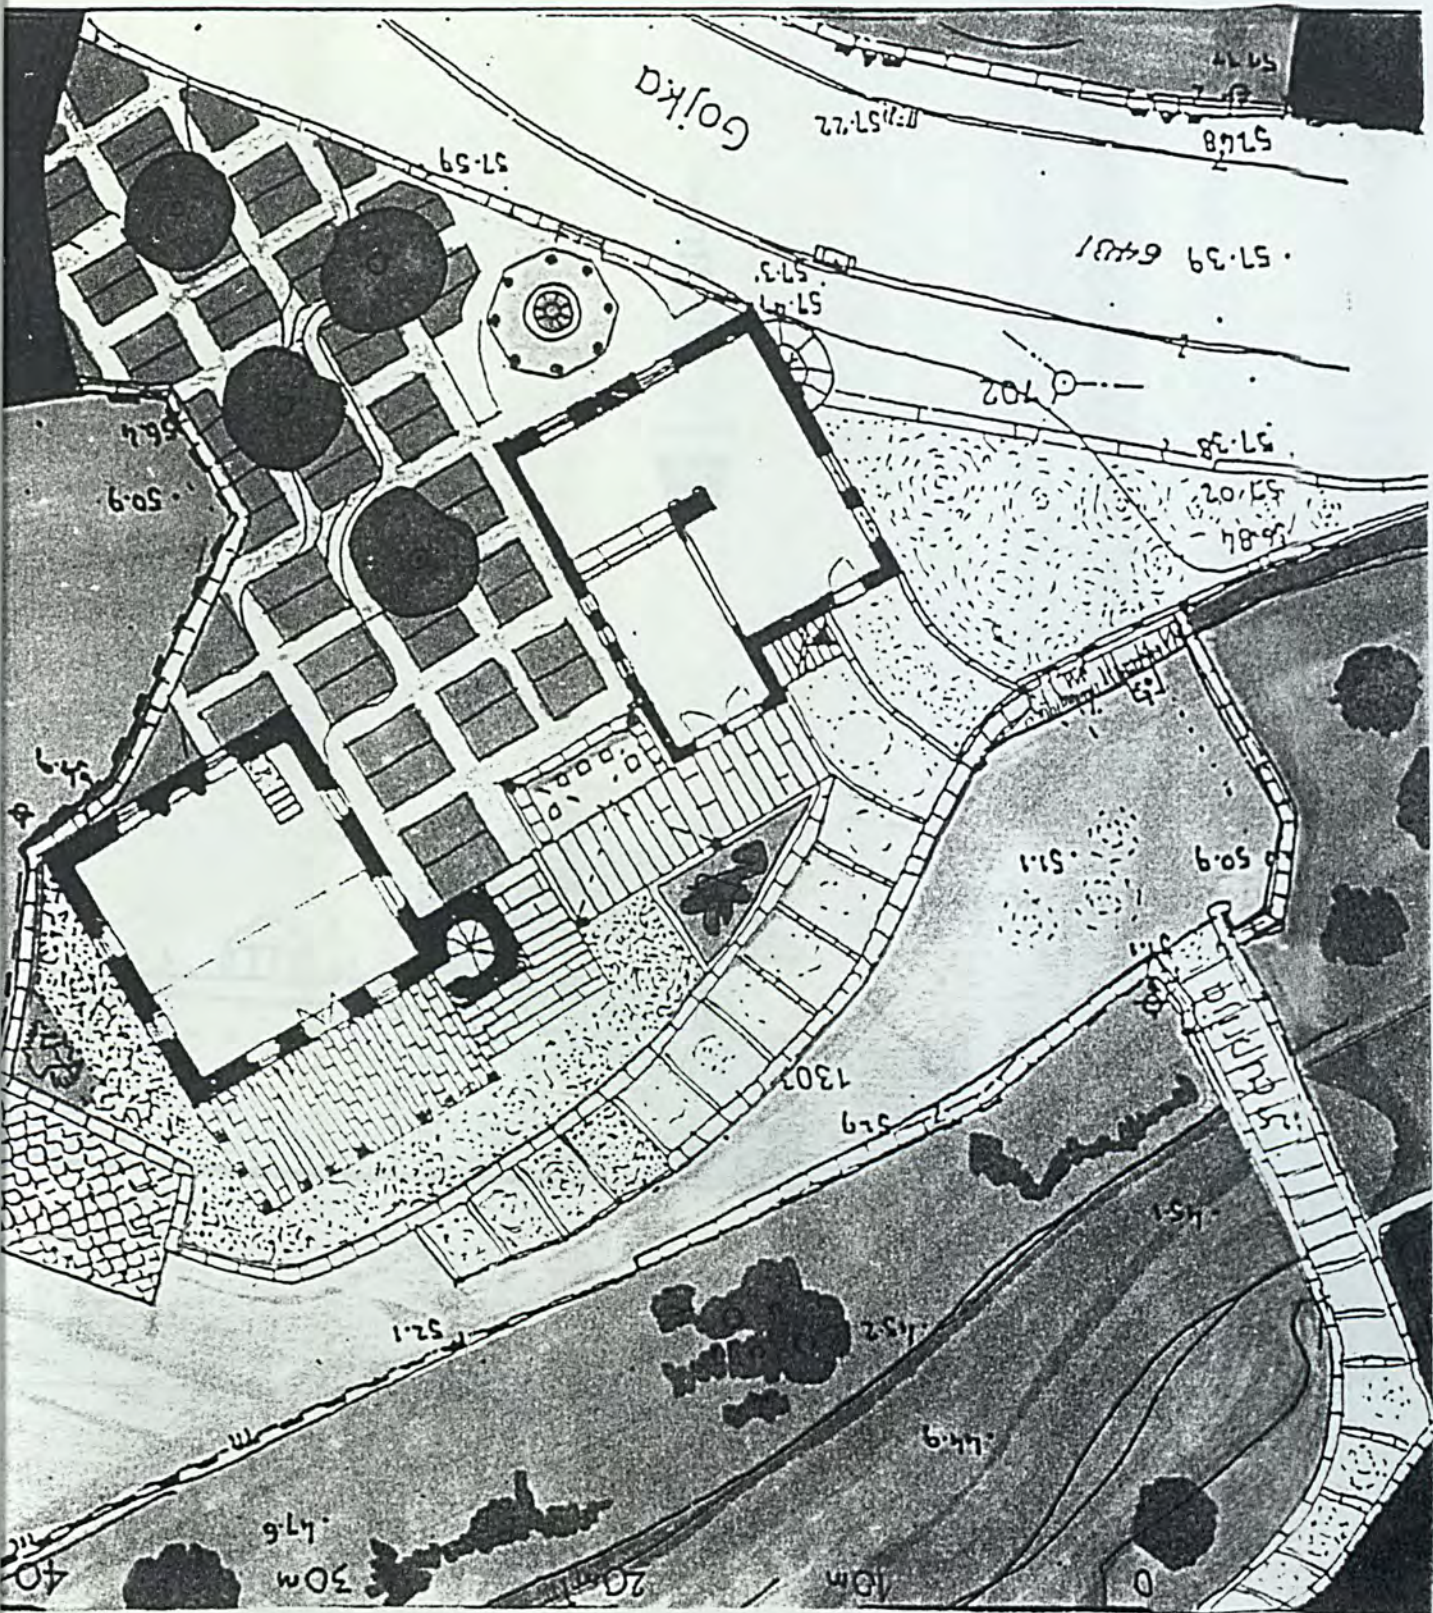
Proposal for reconstruction: Site plan

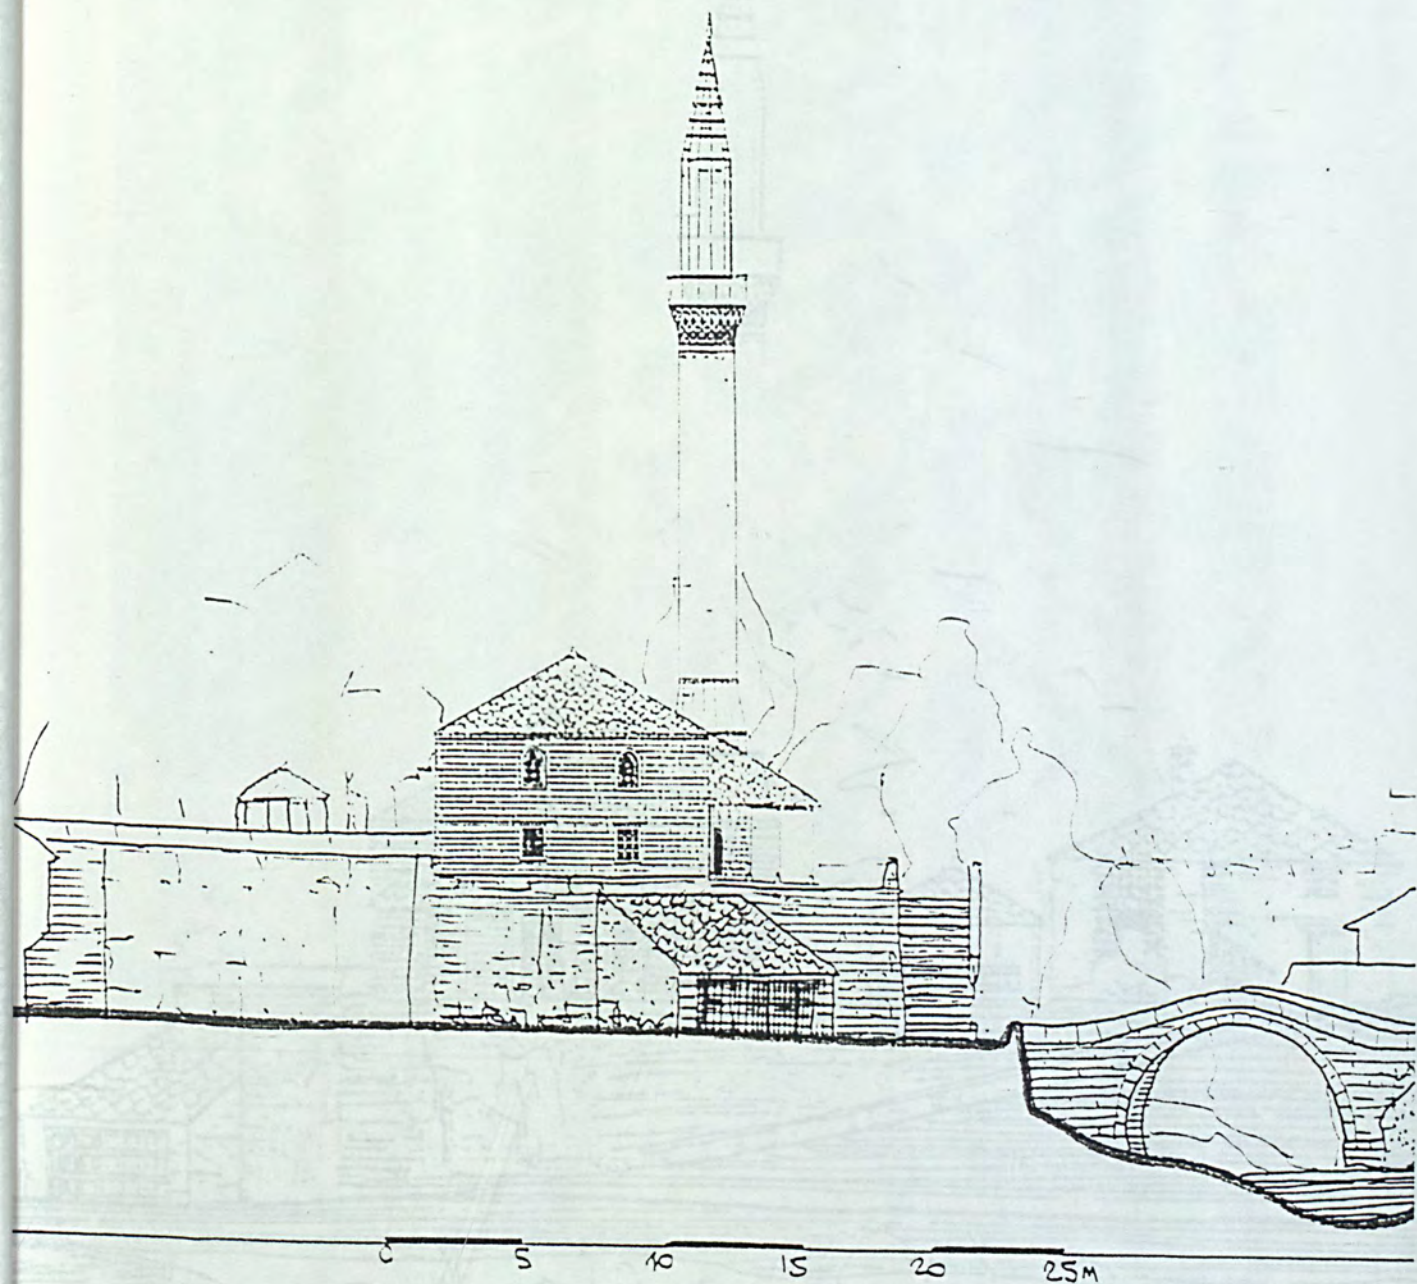
Proposal for reconstruction: Facade

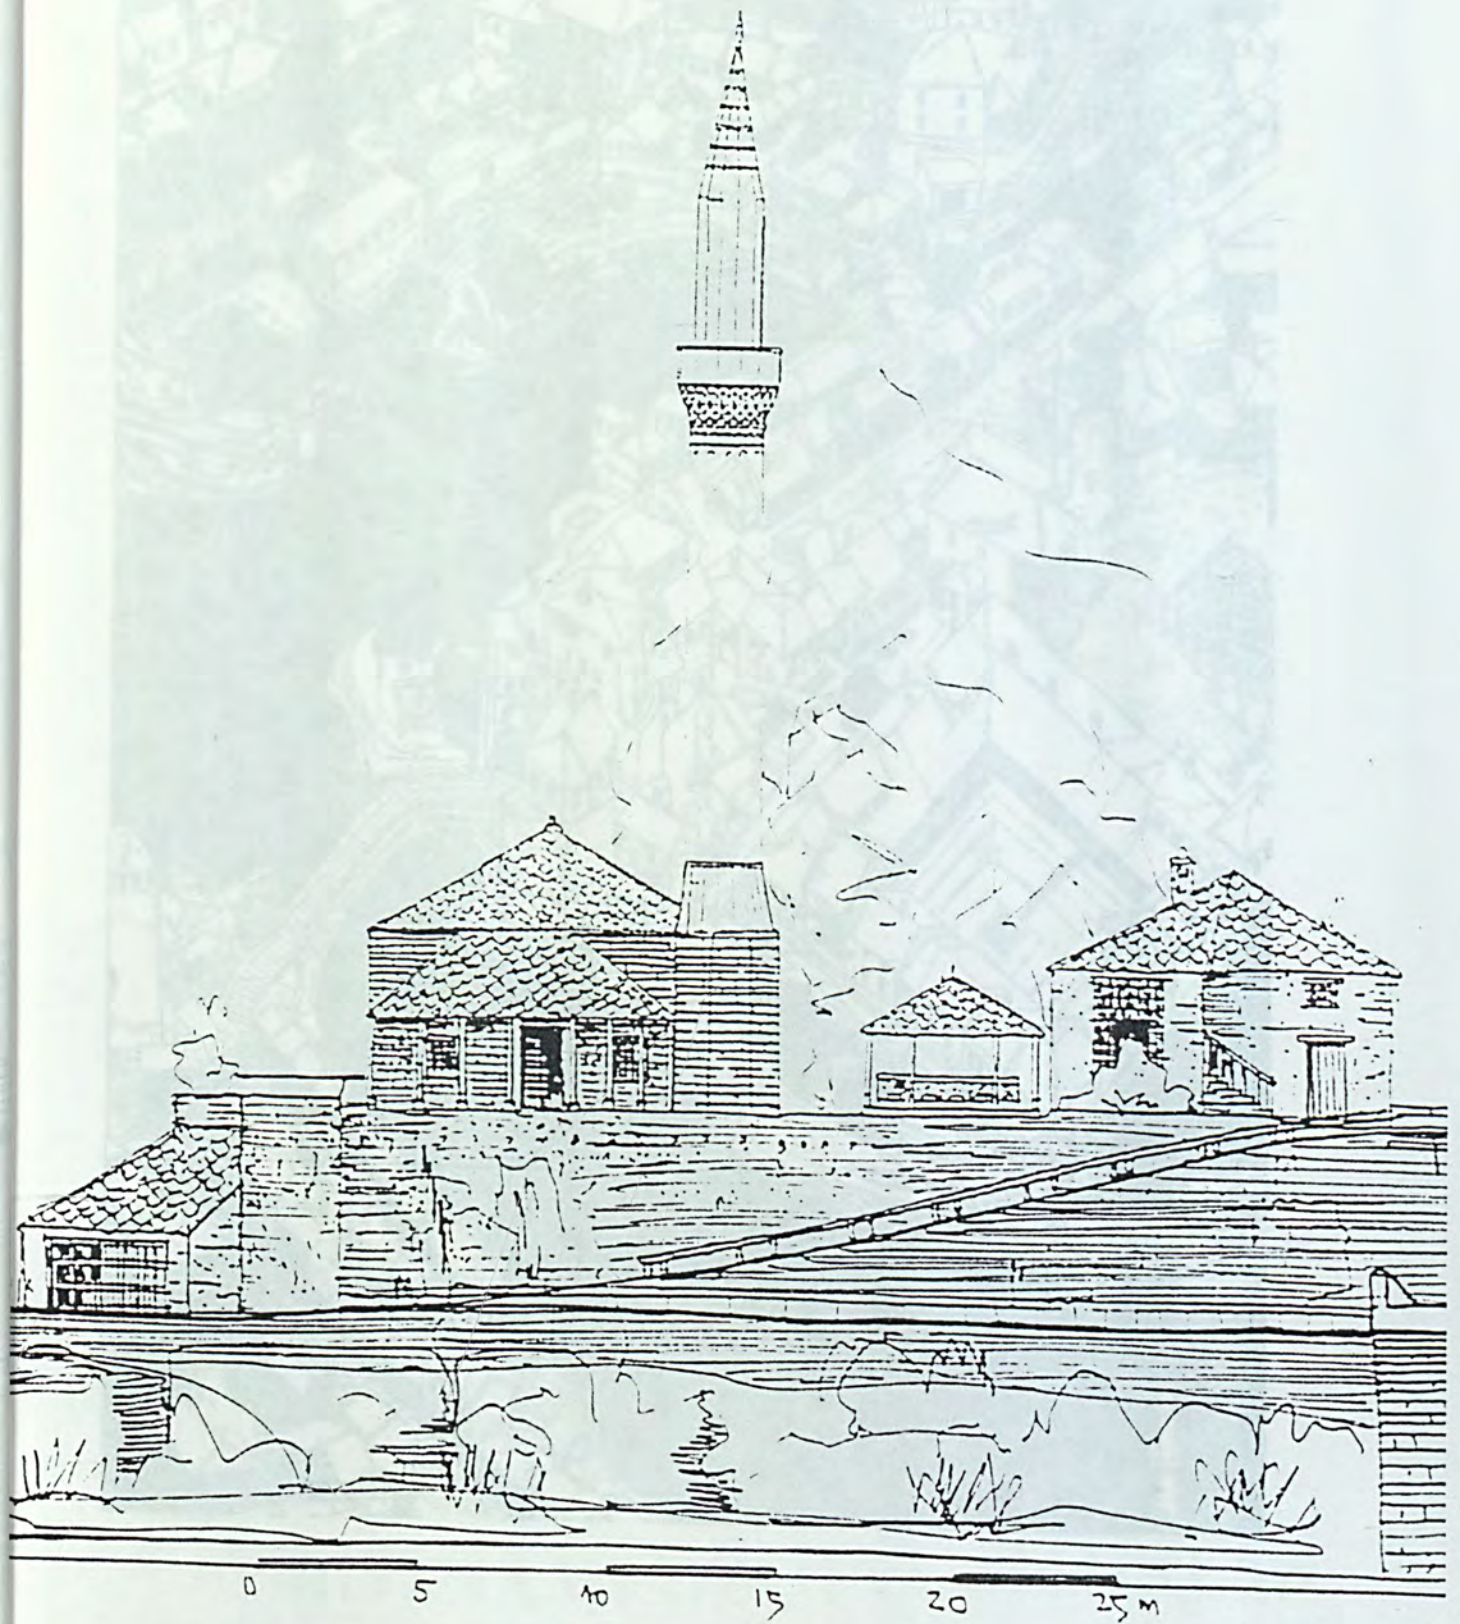
Proposed reconstruction of the facade of the mosque in the village of...

Proposal for reconstruction: Facade

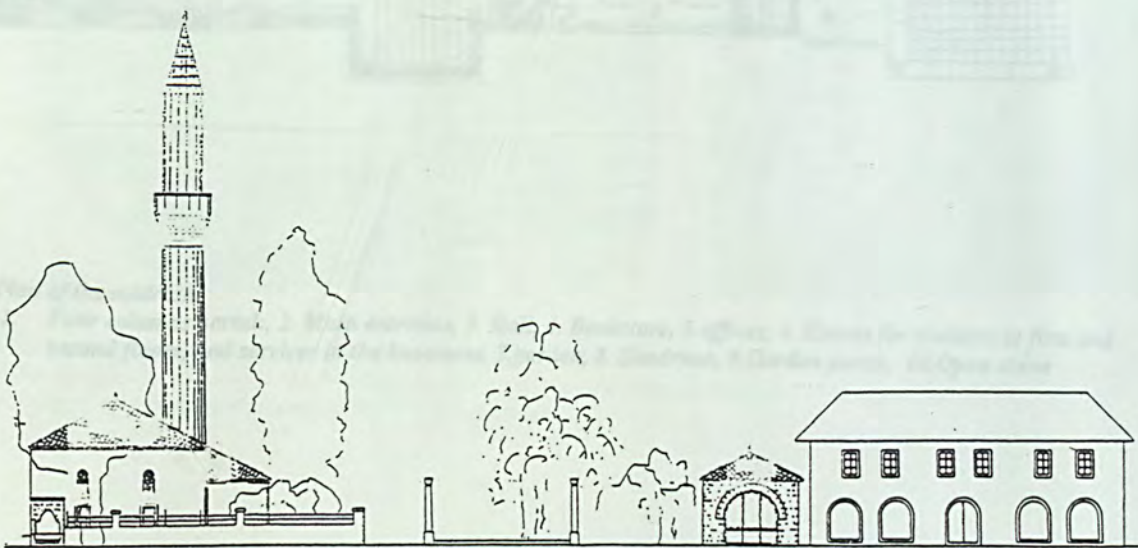
*Facade from the Fejica street*

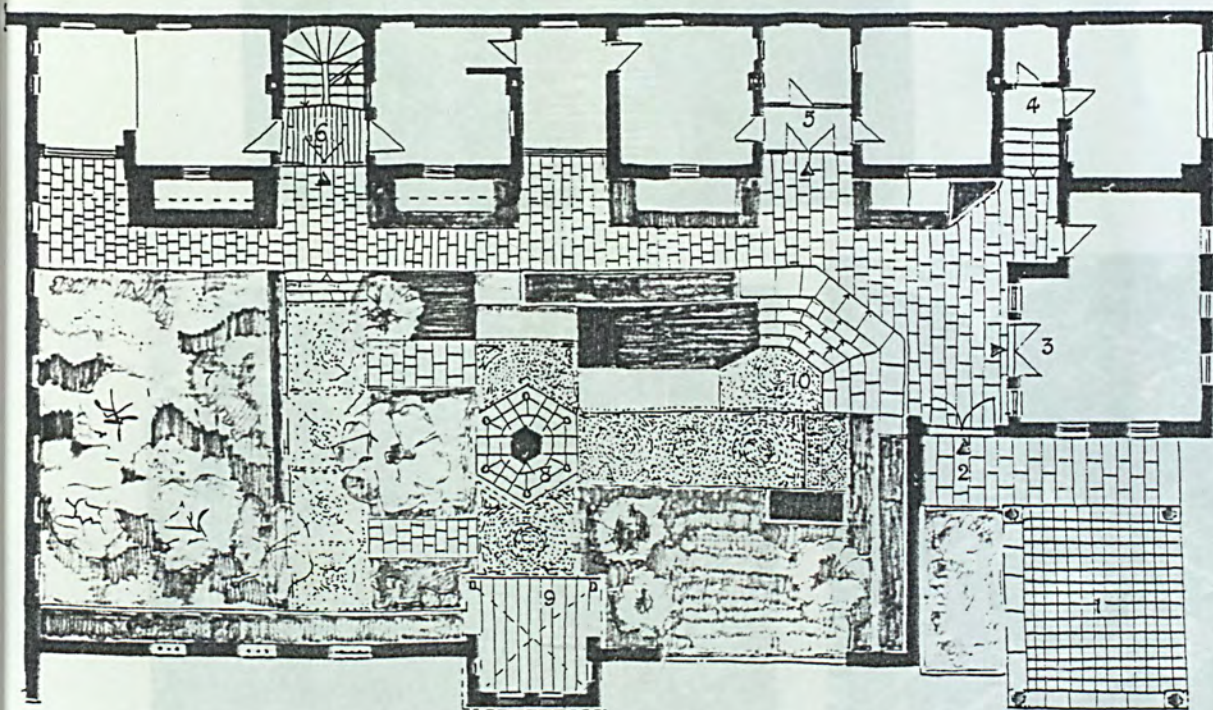
*Plan of the medrese:*

1. Four columns portal.; 2. Main entrance, 3. Hall, 4. Bookstore, 5. offices, 6. Rooms for students at first and second floors, and services in the basement, 7. garden, 8. Shadrvan, 9. Garden porch, 10. Open scene

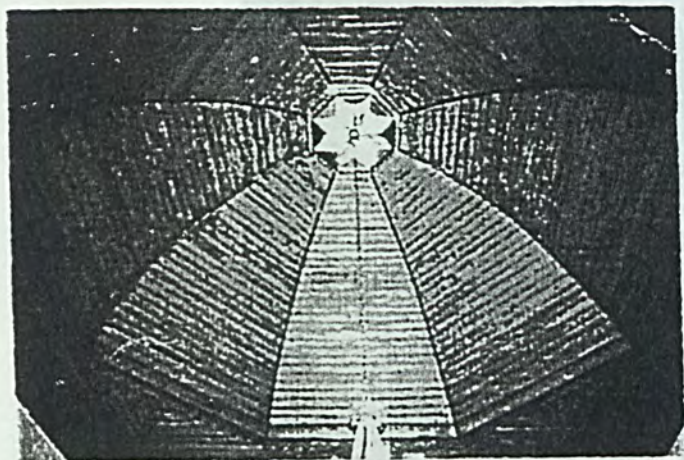
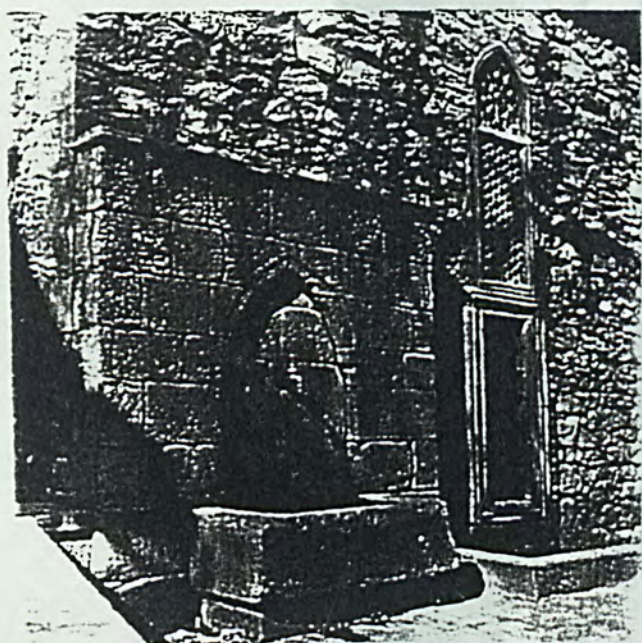
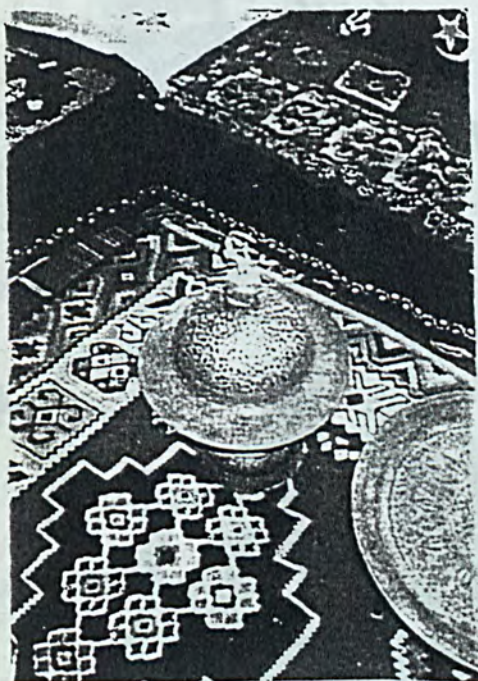
*Traditional architectural elements as an idea for the future decoration of the medrese:  
The fountain and the window from the Roznamdijina mosque, the dome in built under classical roof of the  
same mosque, and interior elements of the Biscevic house*

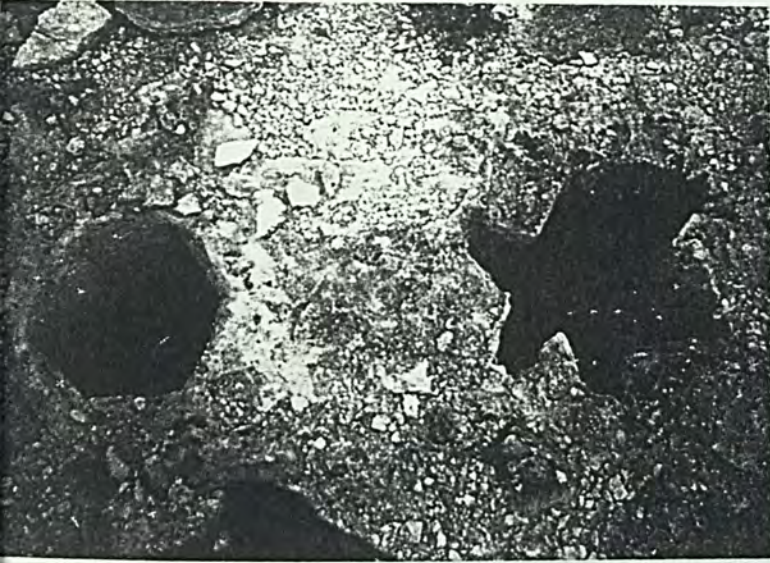
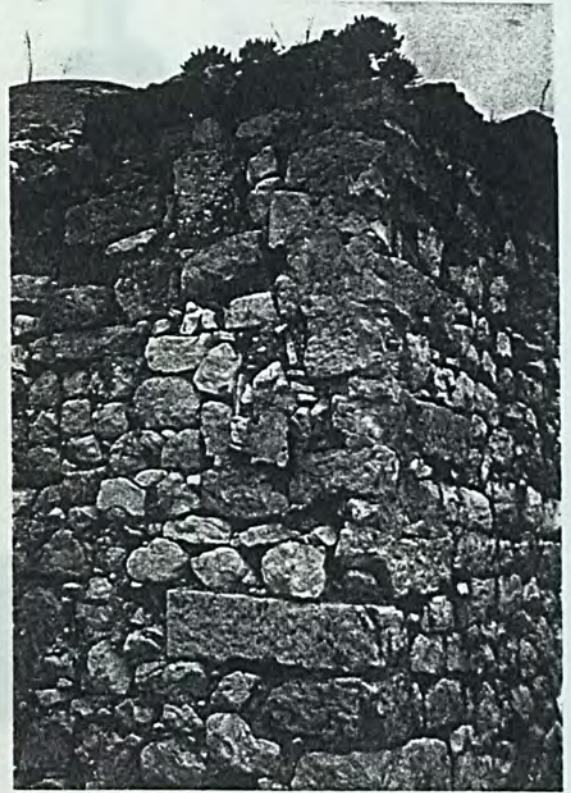
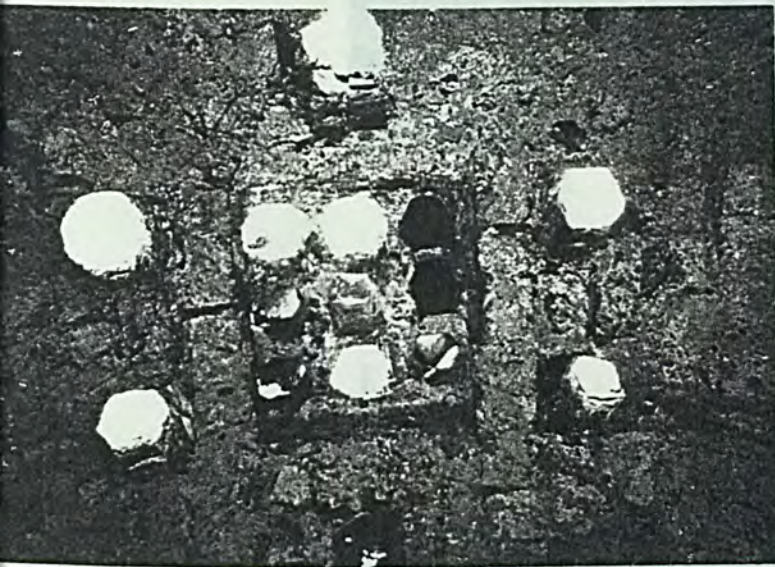
*Details of the hamam: (left) the central dome: openings from outside, and from inside, and pendants, (right) south-east corner, and pipes for a cold and hot water.*

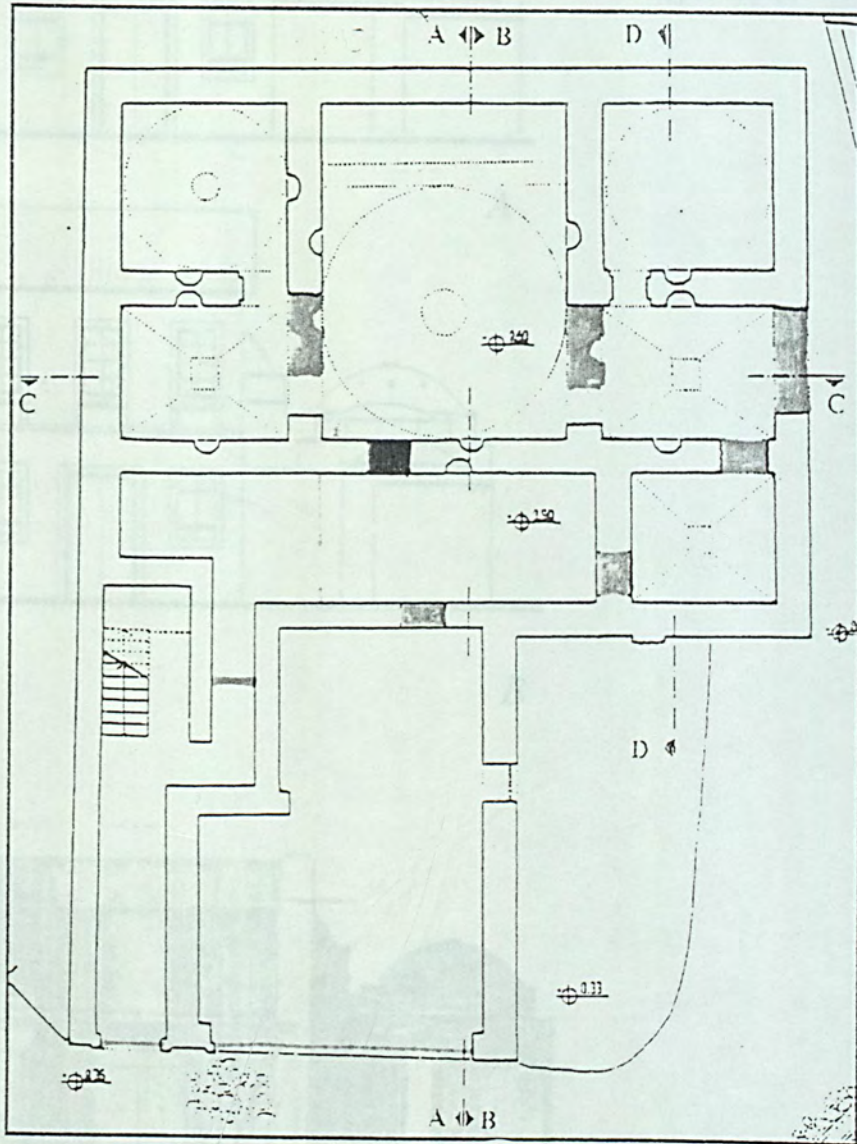
**Hamam: Proposed intervention**  
 To be closed  
 To be reopened

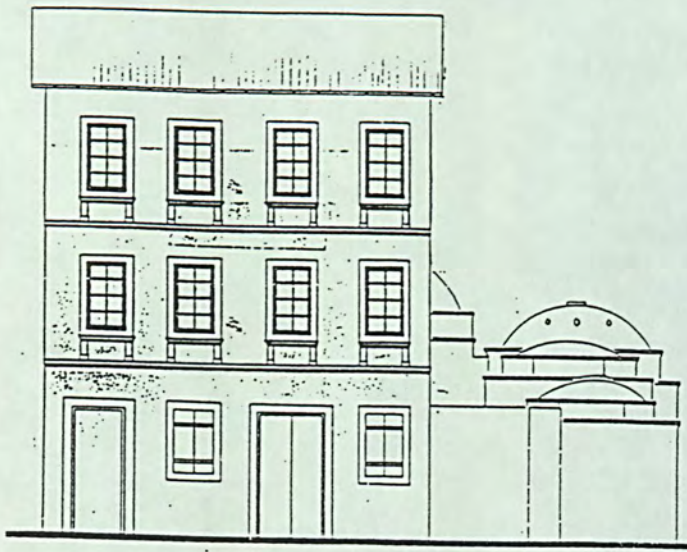
A

- A. To reconstruct in the state before the war?
- B. To reconstruct partly, keeping first and second floor?
- C. To incorporate a new element in the today's existing structure?
- D. To show "addition" to the structure, as

We support the B solution.
